# **Appendix D**

## **Anomaly, Failure and Mishap Reporting**

No.	ID	Title	Status
1.	AMS-02-A01	HV Board Interconnect Failure.	Closed
2.	AMS-02-A02	Uninterruptible Power Supply FET Cracked	Closed
3.	AMS-02-A03	Improper Torquing of ECAL Fasteners	Closed
4.	AMS-02-A04	Anomaly of Thermal Conductor of AMS Internal Tracker	Closed

## Modifications of ECAL, RICH and TOF High Voltage Power Supply QM design

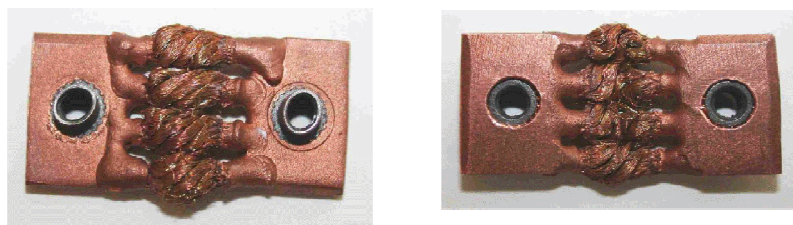
**Observations:** Some threads of the Copper braids used as thermal connectors between inner planes were found to be damaged during the assembly (*See Appendix A*). The damaged threads are broken on one side only and none was found to be loose. The loss of thermal conductivity is negligible.

Compression along Z-axis is applied to the braids in order to restore flexibility and to adjust the length in Z. Pictures below show a connector after compression.

This compression was performed *in situ* during assembly of the 3 planes of the inner tracker but before the definitive connexion. Some braids were damaged:

**Corrective Action:** Heat shrink tubing implemented over braids to contain any possible fragments. Fragment generation unlikely as copper conductors were only broken on one side and still retained on the other. Additional containment within tracker is provided by mesh filters at light tight vents.

**Actions taken:** Study of a containment procedure of the Copper braids using space qualified heat shrink tubing (*See Appendix B*). This tubing must be installed *in situ* after vacuum cleaning of the braids with examination of the filter. The heating should not damage the electronics.
